# 石橋の劣化現況診断・動特性 調査と構造解析

## 3. 調査例 1 : 羅漢寺橋

## 4. 調査例 2 : Tanaro 鉄道橋

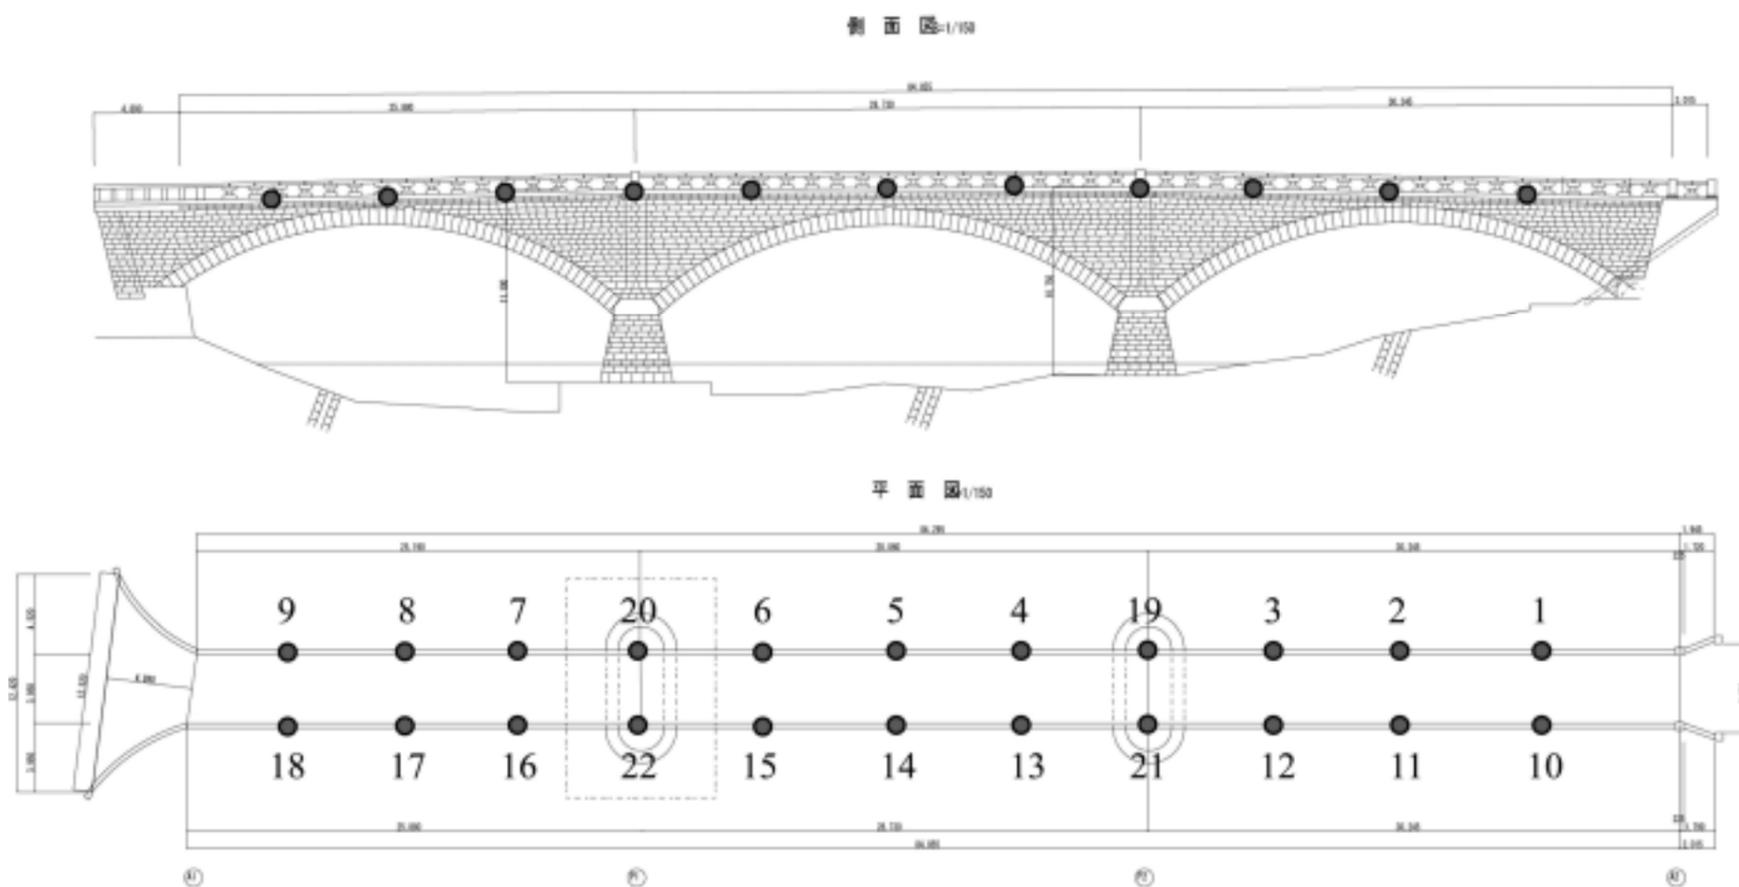
加速度測定位置

固有振動数、固有モード、減衰を推定するための加速度測定は、6個の加速度センサーのうち2個を測定点2と12に固定し、残りの4個のセンサーを移動させる方法で、表に従って5セットの測定を行った。

Setup	Channel					
	1	2	3	4	5	6
1	2	12	1	3	10	11
2	2	12	4	5	13	14
3	2	12	6	7	15	16
4	2	12	8	9	17	18
5	2	12	19	20	21	22

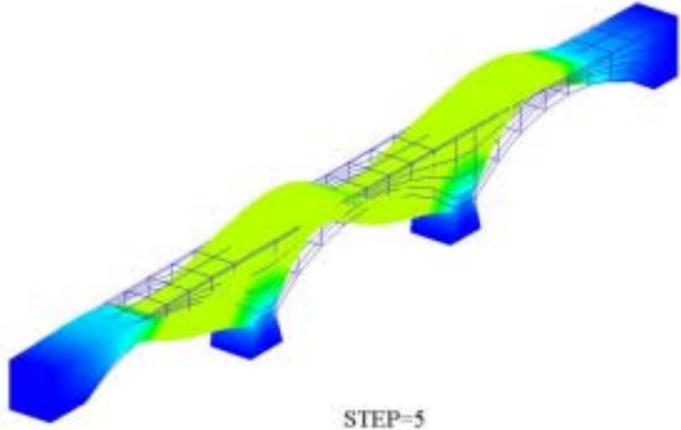
<p>STEP=5</p> <p>10.68Hz</p>

# FEM による値と ARMAV による実験値の比較

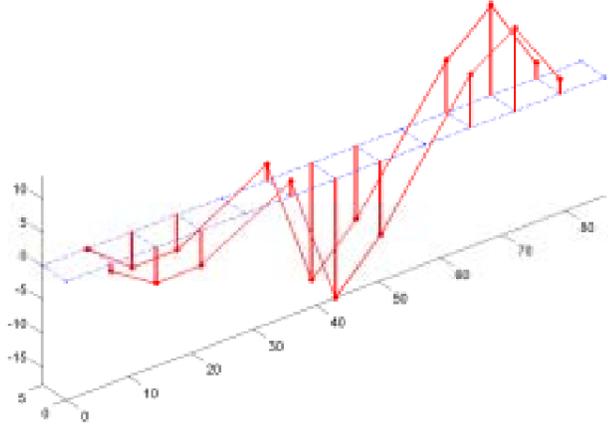
<p>11.26Hz</p>

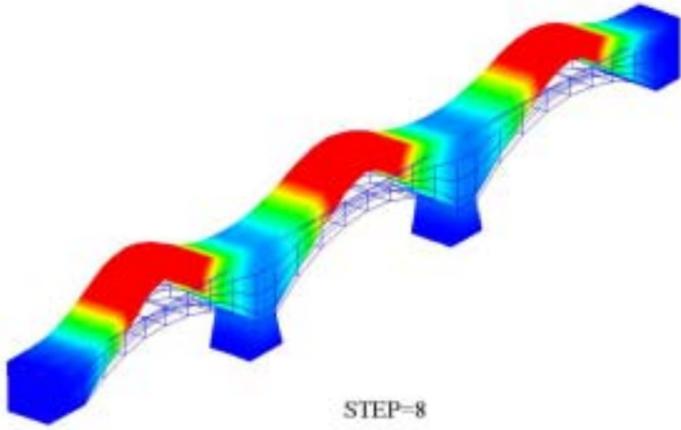
<p>STEP=8</p> <p>12.12Hz</p>

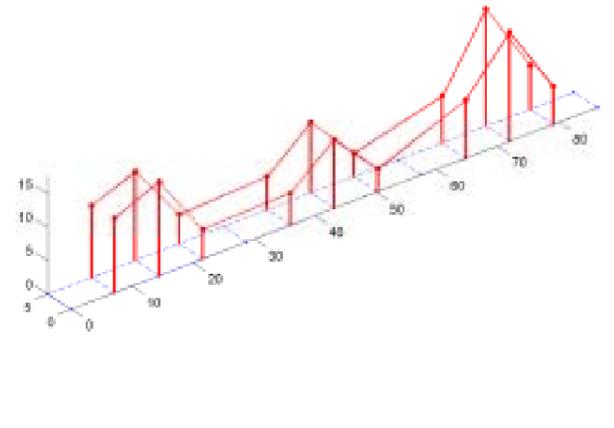
<p>12.01Hz</p>

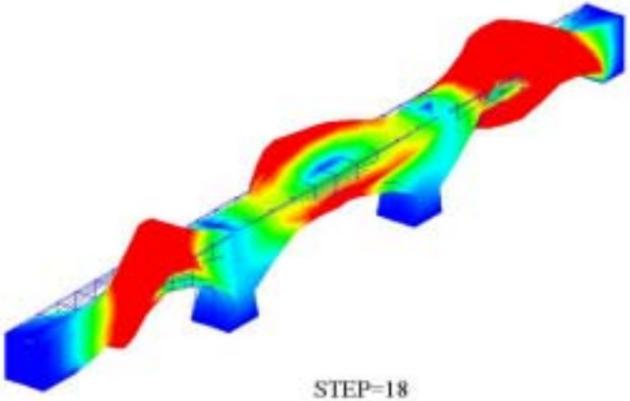
<p>STEP=18</p> <p>24.69Hz</p>
